ARMY AVIATION TEST BOARD FORT RUCKER ALA PRODUCT-IMPROVEMENT TEST, OH-6A MAINTENANCE PLATFORM.(U) JUN 68

SUBJECT: Final Report of Test, Product-Improvement Test, OH-6A

Maintenance Platform, USATECOM Project No. 4-6-0251-

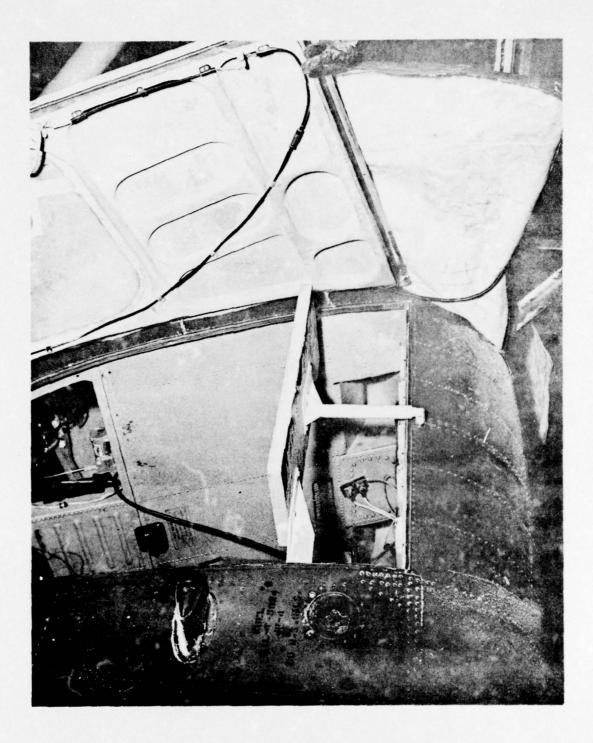
Figure 1.

- 3. Description of Materiel. The maintenance platform (figure 1, inclosure 2) attaches to the jack point on the right side of the aircraft at the cargo door. This non-adjustable platform is positioned for direct access to areas above the right cargo door and is designed to be stowed internally within the aircraft cargo compartment. The surface of the platform is coated with an antiskid material to permit use during wet weather and to minimize the adverse effects of spilled oil or grease.

- d. USABAAR personnel found that the platform working area was not sufficiently large to permit safe inspections of both the engine inlet and main-rotor hub areas. Maintenance personnel standing on the platform and attempting to gain access to the engine inlet area had to lean sideward at least 30 degrees toward the rear of the aircraft, remove one foot from the platform, and maintain balance.

- e. The following design deficiency was found: Present platform working area and position preclude safe and effective access to both the engine inlet and the main-rotor hub areas (paragraphs c and d, above). An increase of platform working area length to 48 inches should allow safe access to the engine inlet area and decrease the safety hazard associated with the test platform.

- 7. Conclusion. The maintenance platform in its present configuration is not suitable for use on the OH-6A.
- 8. Recommendation. It is recommended that the design deficiency be corrected by increasing the platform working area to allow safe and effective access to the engine inlet.

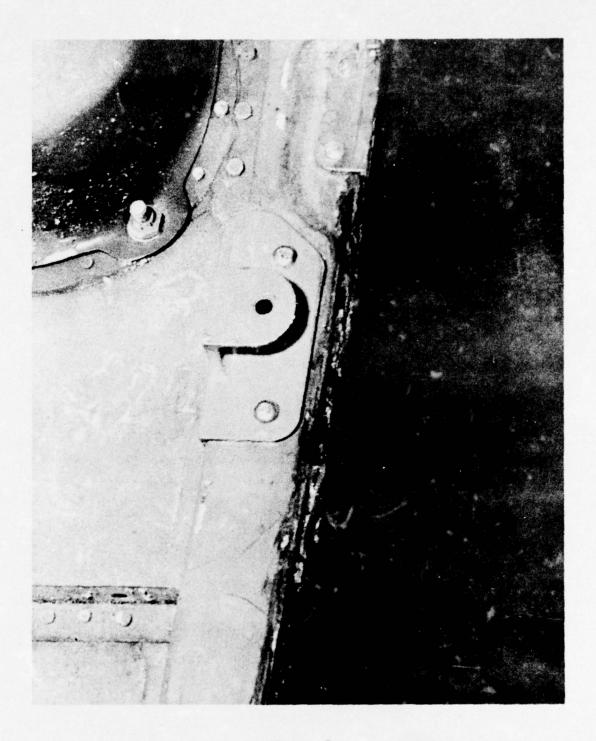
Figure 2.

b. Special installation hardware consisted of a bracket which attached to the inside right-hand aft cargo door frame (figure 2, inclosure 2). This bracket and the jack point below the door insure rigidity of platform installation. One man-hour, including time required to gain access to the work area, was necessary for bracket attachment.
